All Crash Parts

Information Bulletin

Issue raised: **Nissan Navara D21 Guards**

Date identified: **16/03/04**

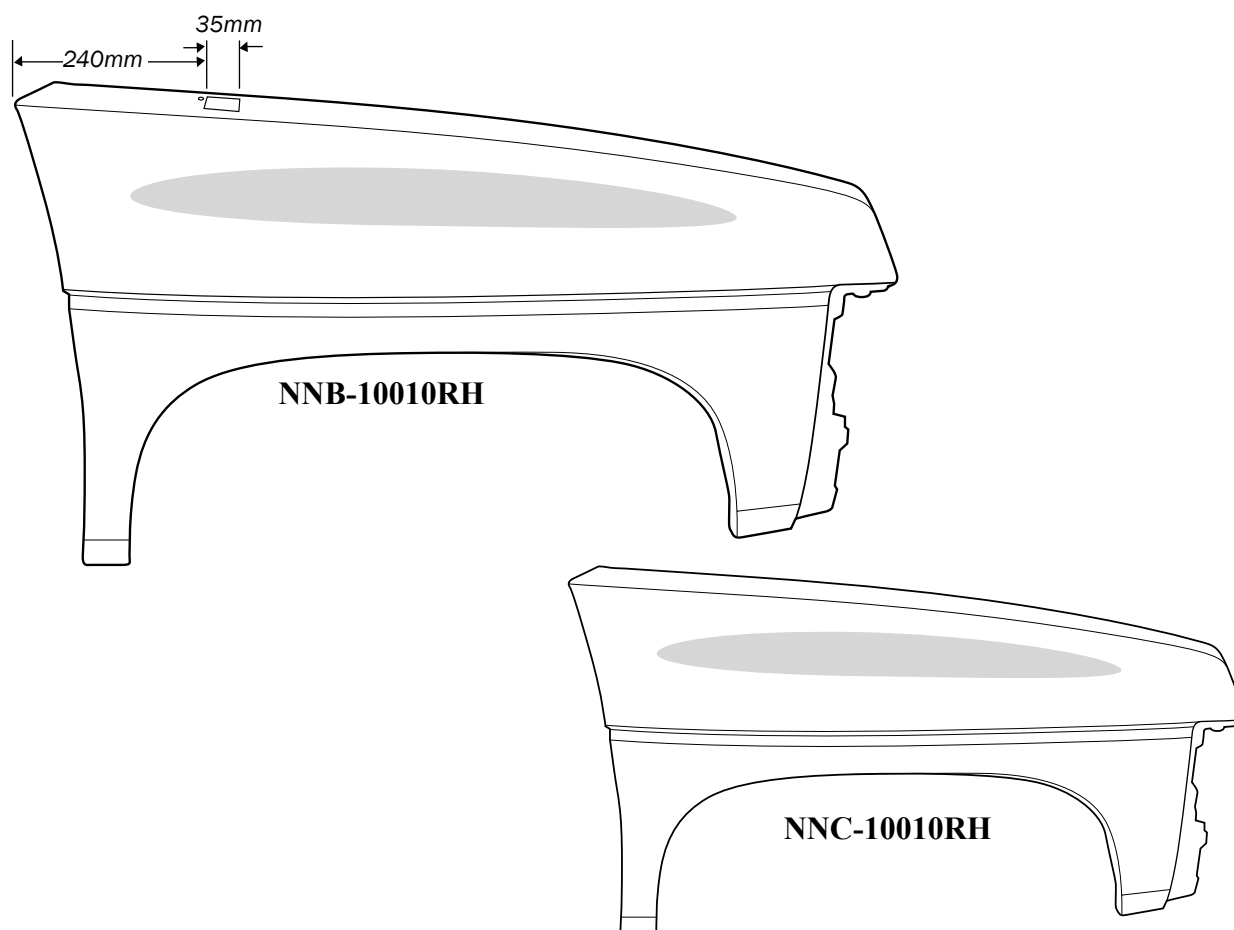
This bulletin is to inform you of the differences in the Navara D21 guards with the part numbers **NNB-10010RH** and **NNC-10010RH**. Part number **NNB-10010RH** (1/86 - 5/92), has an aerial cutout as shown in the diagram below. Part number **NNC-10010RH** (6/92 - 3/97), does not have an aerial cutout, therefore you are required to cut the hole in the position required (if required).

Note: If the original guard has an aerial cutout then compare its positioning to the replacement guard prior to fitment to ensure the guard is suitable, see dimensions below.
